Valve Spindle – Valve Stem

Food Processing –Vegetable Steam Peeling

Customer: Odenberg, Belgium
Product: Valve Stems
Application: Vegetable Steam Processing
Install Date: 2006

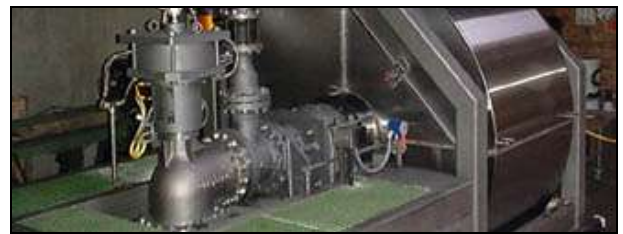
Odenberg part no. P0101192

The vegetable plant experienced heavy corrosion. It has been observed that the 36 mm diameter spindle in AISI 316L has completely eroded in a time frame of 4 months.

A **Tantaline JobShop** solution was applied in the spring 2006.

The Tantaline valve spindles are still in use and no failures have been reported to date.
